Lookout Show`n Tell #13 – Lightning Protection at Lookouts

**Ray Kresek
Fire Lookout Museum
Spokane, WA**

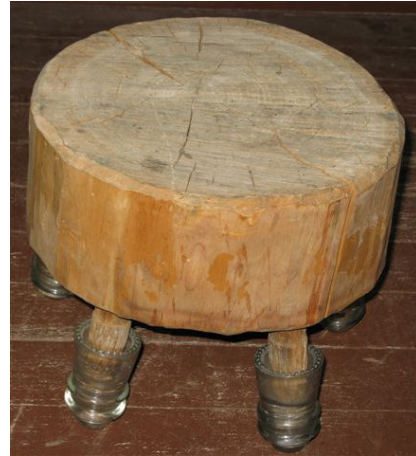
Lightning Stool

The lightning stool or proverbial "Hot Seat" was designed simply and may be found in many forms, using telephone insulators on the feet. It was intended to be stood on during a storm when you needed to use the land line phone or radio. Some today say you should perch your toes on it like an eagle through the entire overhead attack. Others say it's useless. You can be the judge...

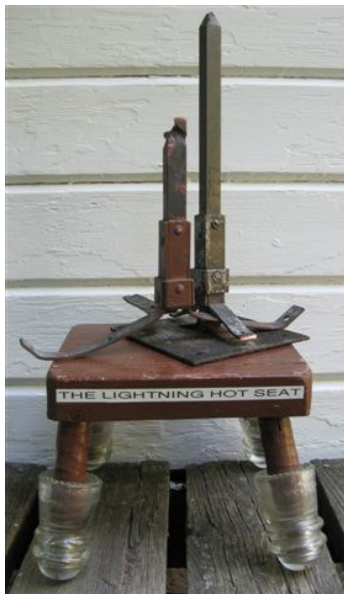
Lightning Hot Seat & Damaged Lightning Rods

The lower two pictures show a couple of copper lightning rods from LO roof tops. Both were damaged by direct lightning strikes. One shows several small arc beads on its tip. I can attest to the fact that this one did some damage at Heavens Gate LO, Idaho in 1988. I was there. The direct hit wiped out all 6 radios, the propane fridge, and bit my dog on the nose! The system was maintained properly, supposedly.

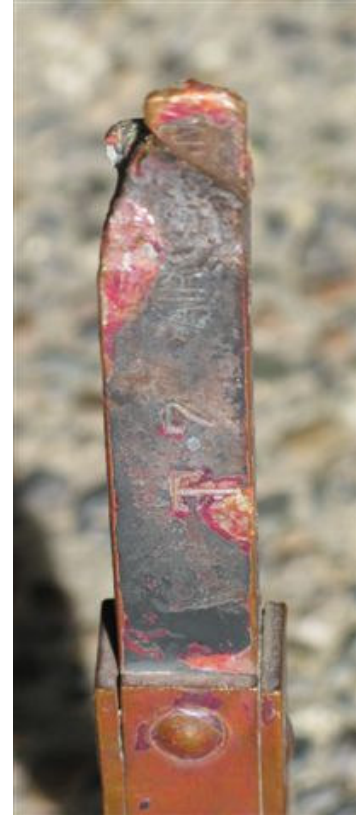
Burnt Lightning Air Terminal 2

This burnt air terminal wasn't so lucky. Its electrical connections hadn't been properly maintained, and a direct strike burnt down the lookout at Simmons Ridge, Idaho.
